Bridge Engineering Institute Conference 2019 (BEI-2019)
Honolulu, Hawaii, USA, July 22-25, 2019

Analytical Estimation on Remaining Load Bearing Capacity of Aging Truss Bridge by Using Whole Bridge Modeling

Keywords: pony truss; non-linear FEM; shell element; load bearing capacity; collapse behavior

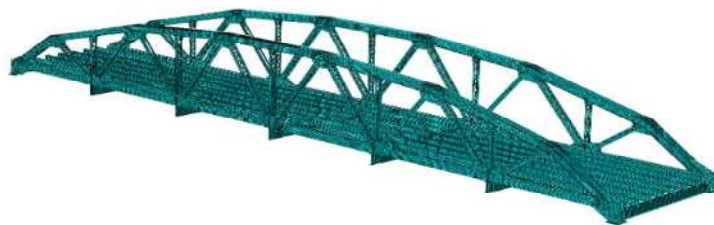
Fig. 1. Analytical model

The non-linear finite element analyses in this study were performed by using ABAQUS/Standard 6.14-5. Fig. 1 shows the analytical model in this study. In this model, all main structural members are constructed by the shell element with 4 nodes, and the all rivet joints were modeled as the rigid connection. The size of each shell element was set to under 40mm square in order to consider the corrosion damages which have a certain area. Based on the tensile tests, the material properties were assumed to be elastic modulus $E=203.5$ [GPa], yield stress $\sigma_y=312.3$ [MPa], and Poisson's ratio $\nu=0.274$ respectively. The stress-strain relation was assumed to the perfect elasto-plasticity. For the boundary conditions, the rotations and displacements in all directions are fixed based on the actual state, because all shoes are fixed directly to piers by using 4 anchor bolts in a base plate. The RC slab is not modeled, because it is not structural member for main loads. In the corrosion modeling, the maximum corrosion depth was applied to the entire corrosion area.

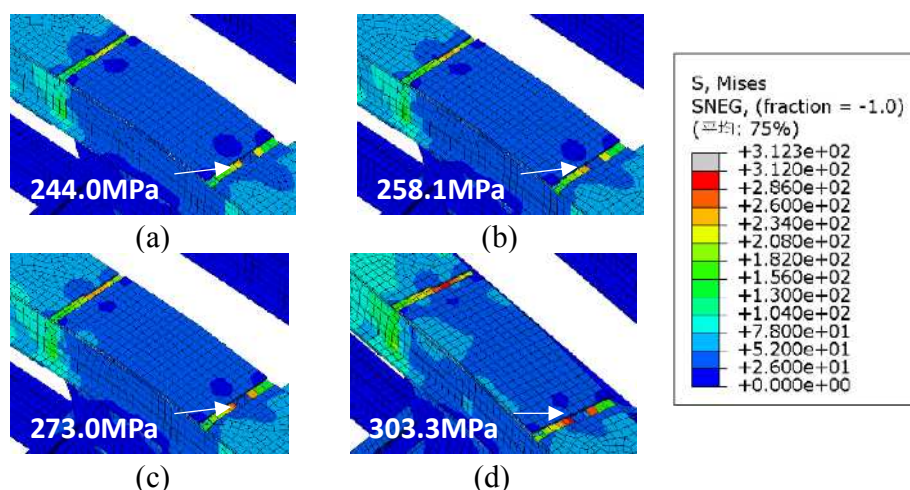
Fig. 2. Mises stress distribution around the groove-like corrosion (Case-1): (a) T-4 truckload; (b) T-6 truckload; (c) T-9 truckload; (d) T-14 truckload

Fig. 2 shows the Mises stress distribution diagram focusing on the groove-like corrosion occurring in the upper chord member at center span when T-4~14 truckload was loaded. The stress around the groove-like corrosion increases as the truckload increases and concentrates particularly around the through hole. When T-14 truckload was assumed, the stress level reached to almost σ_y . Assuming a T-4 truckload which was the minimum required load for this bridge, the stress generated in this part was 244MPa, and the yield safety factor was 1.3. However, the

corrosion damages in this analytical model were modeled larger than the actual state, and the traffic frequency of 3-ton truckload or more was low. So, it is thought that current state of this bridge will not be serious condition soon. If more life extending is considered, the load restriction of 4-ton and repair to the groove-like corrosion of the upper chord member may come in sight view.

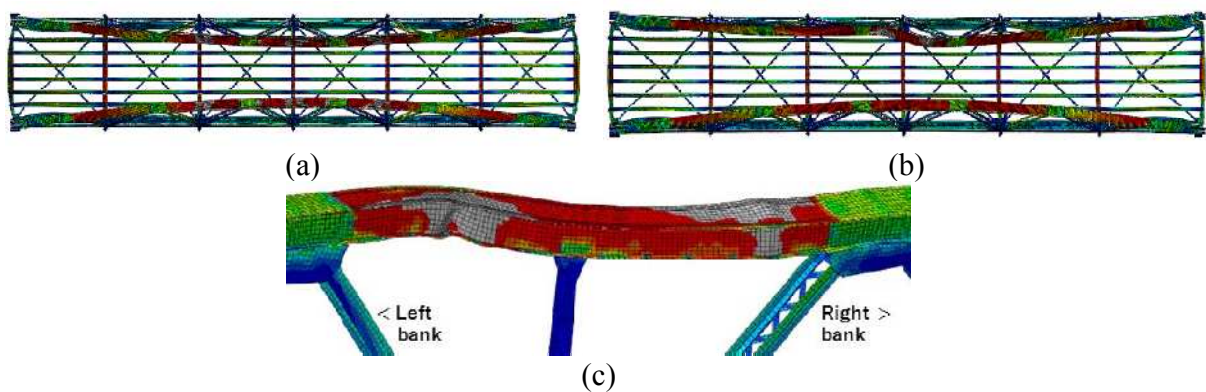
Fig. 3. Deformation ($\times 20$) and stress distribution in ultimate state (Case-2): (a) $\alpha_{cr}=6.91$ at peak load; (b) $\alpha=6.62$ after peak load; (c) Out-of-plane buckling of upper chord member

by the magnification factor α . From Fig. 3 and Fig. 4, Case-2 without corrosion was disintegrated at $\alpha_{cr}=6.91$, but Case-3 with corrosion damages collapsed at $\alpha_{cr}=5.28$. These results will mean that load bearing capacity of whole bridge decreased by 24% due to corrosion for 99 years. Also, in both Case-2 and Case-3, though the buckling was occurred in the ultimate state on same upper chord member at the center span of downstream side, the direction of buckling was different each other. It could be confirmed that the buckling behavior will change from out-of-plane buckling caused by full cross-section yielding to in-plane buckling due to pitting corrosions on upper flange.

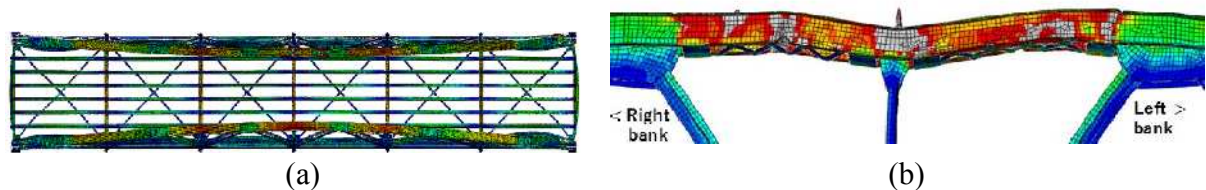
Fig. 4. Deformation ($\times 20$) and stress distribution ($\alpha_{cr}=5.28$) (Case-3): (a) Plan view; (b) In-plane buckling of upper chord member

- 1) Assuming a 4-ton truck load, the stress concentration occurred in the groove-like corrosion at the upper chord member. The safety factor to the yield state of this bridge was estimated as 1.3. However, it is thought that current state of this bridge will not be serious condition soon.
- 2) It will be estimated that the ultimate load bearing capacity of this bridge has decreased by 24% due to extensive corrosion and severe corrosion accompanied like through holes.
- 3) The main collapse trigger of entire bridge was the local buckling toward in-plane direction on an upper chord member at center span. This buckling was caused by a lot of large pitting corrosions on upper flange.
